IED Report

TITLE: (EXPLOSIVE HAZARD) IED EXPLOSION RPT (Directional IED) 2-5 CAV,
1-1 AAB IVO (ROUTE MSR TAMPA): 0 INJ/DAM

TRACKING NUMBER: 20111122093938SMB5438217977

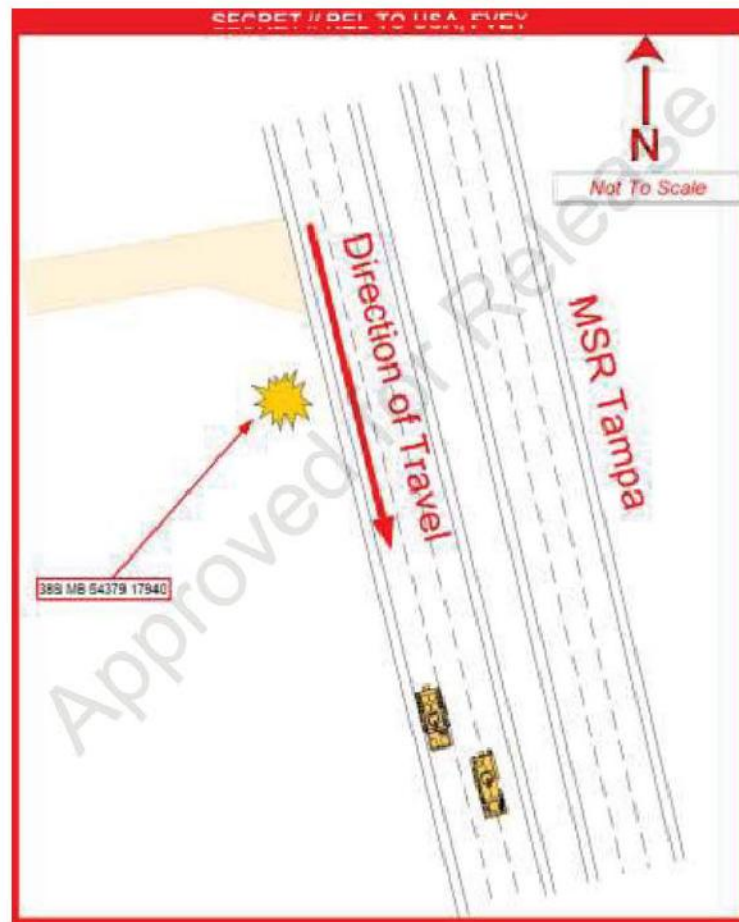
Scene Diagram

~~(SECRET // REL TO USA, FVEY)~~ 752/2/2 responded to a PBA at 38S MB 54379 17940 ISO 1/1 CAV. arrived on scene and the Barbarian Blue Commander reported that while traveling south on MSR there was a detonation next to the lead vehicle on the west side of the road. Vehicle pushed through blast area and stopped approximately 100m from the blast seat. Team performed a recon and explored the site. Team discovered that the blast damage to the vehicle was consistent with a (b)(1)1.4c blast seat was 20' from the road and measured 40" x 32" x 8" deep. The blast seat was consistent with approximately 30 pounds of unknown bulk explosives. Team discovered no further evidence to support device initiation and found no further explosive hazards. MC: 221140CNOV11.

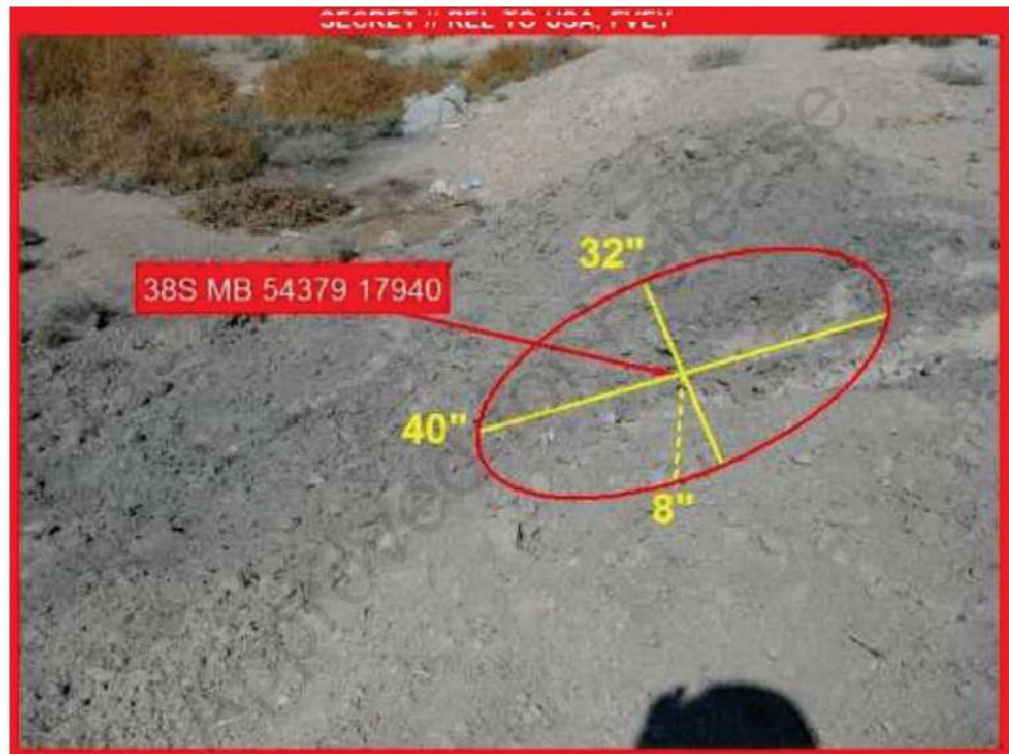
Blast seat

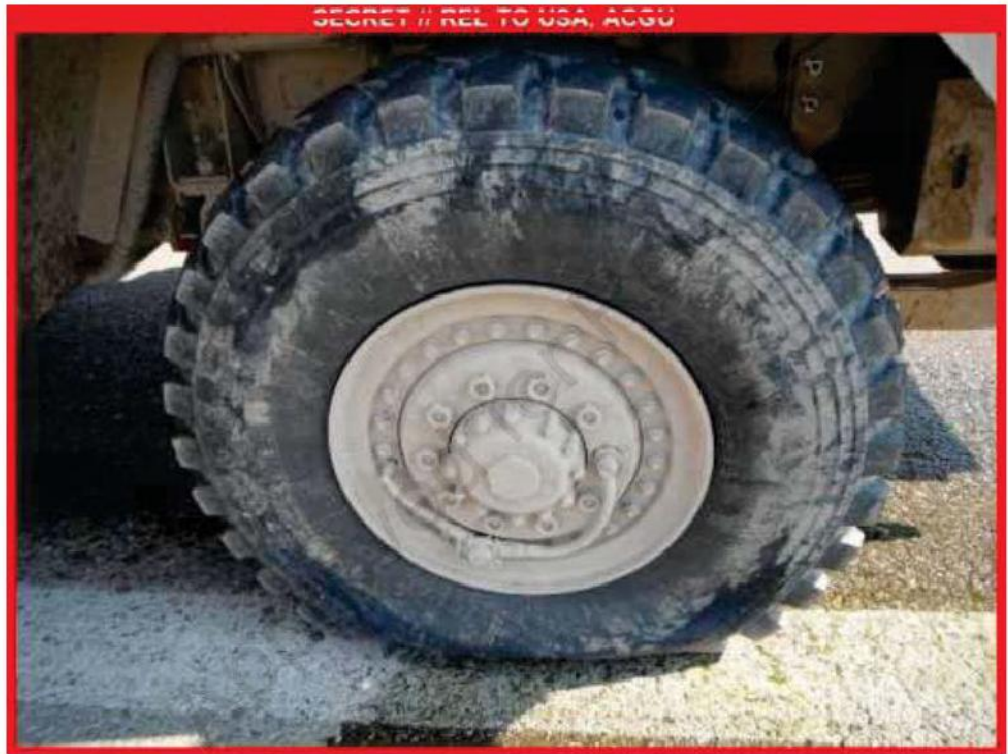
(b)(1)1.4c

found on tire rim

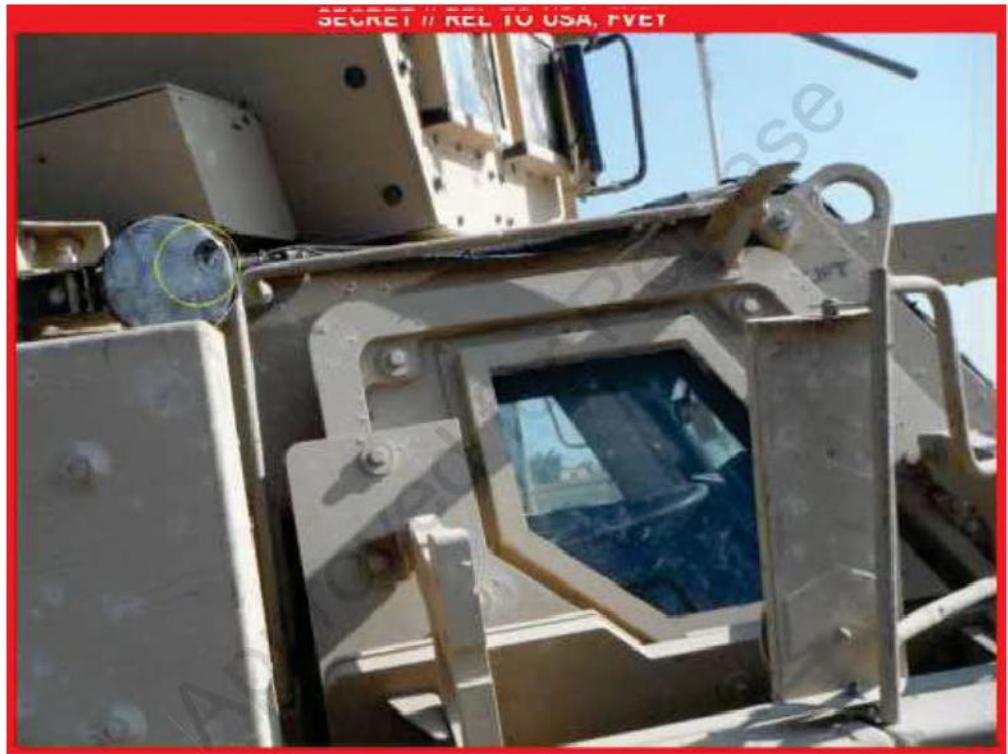
Vehicle damage

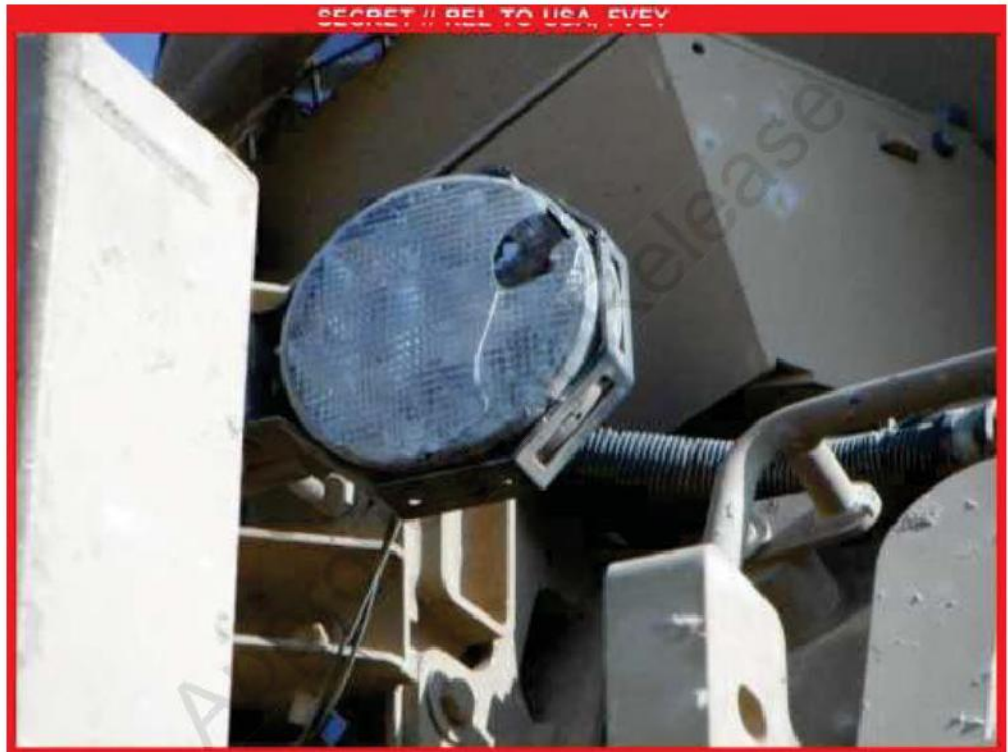
Damage to light

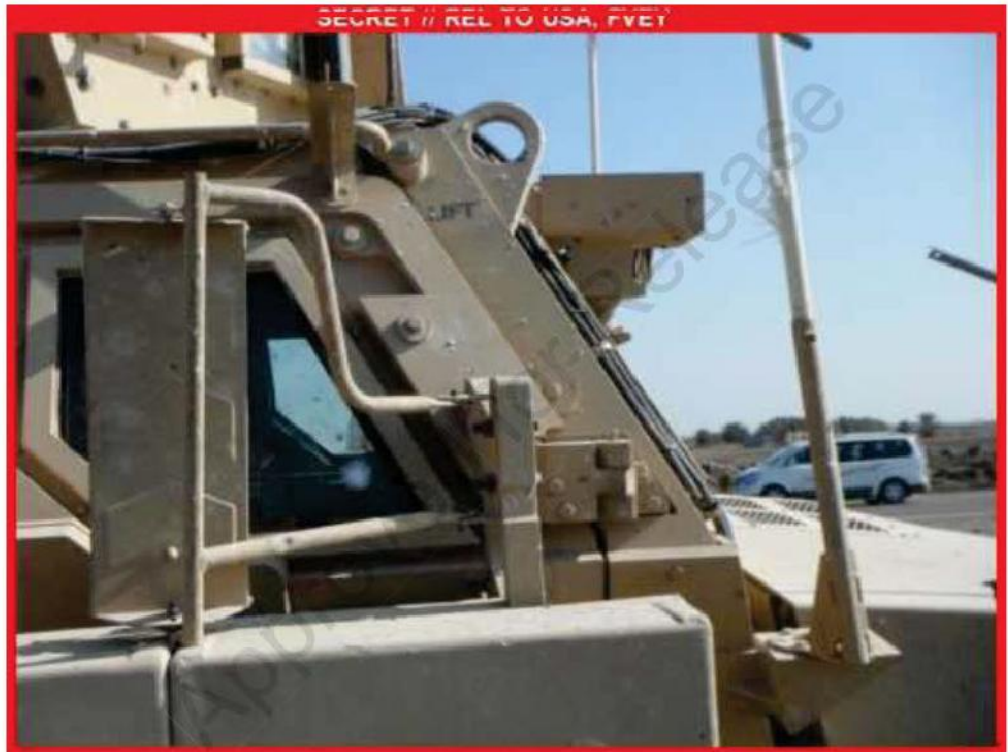
Vehicle damage

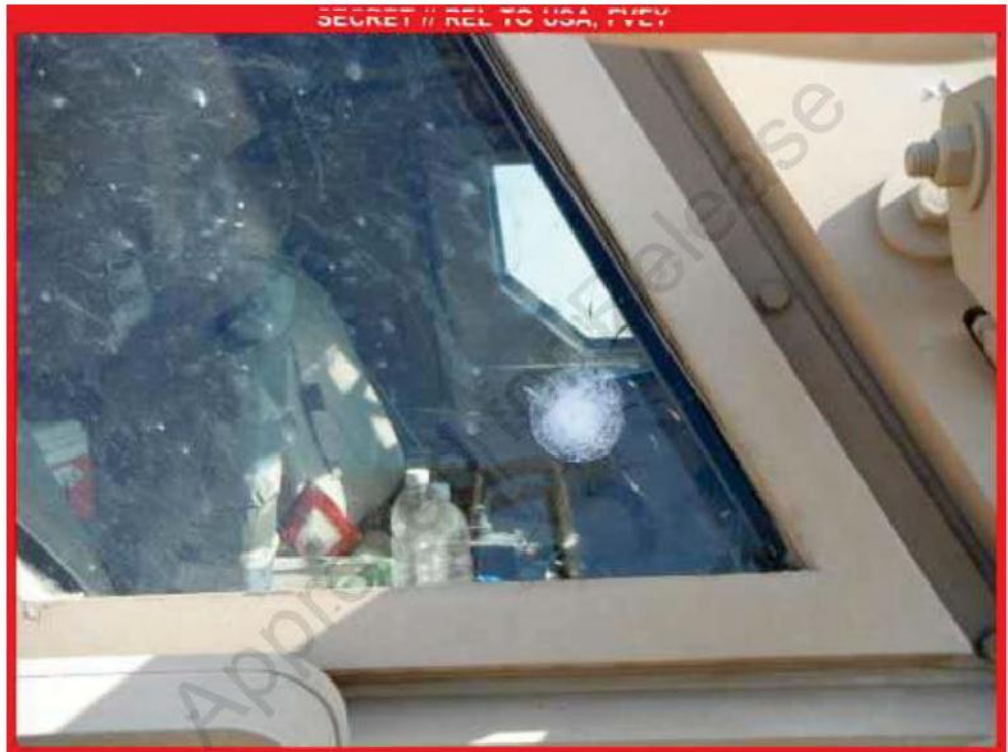
Damage to TC window

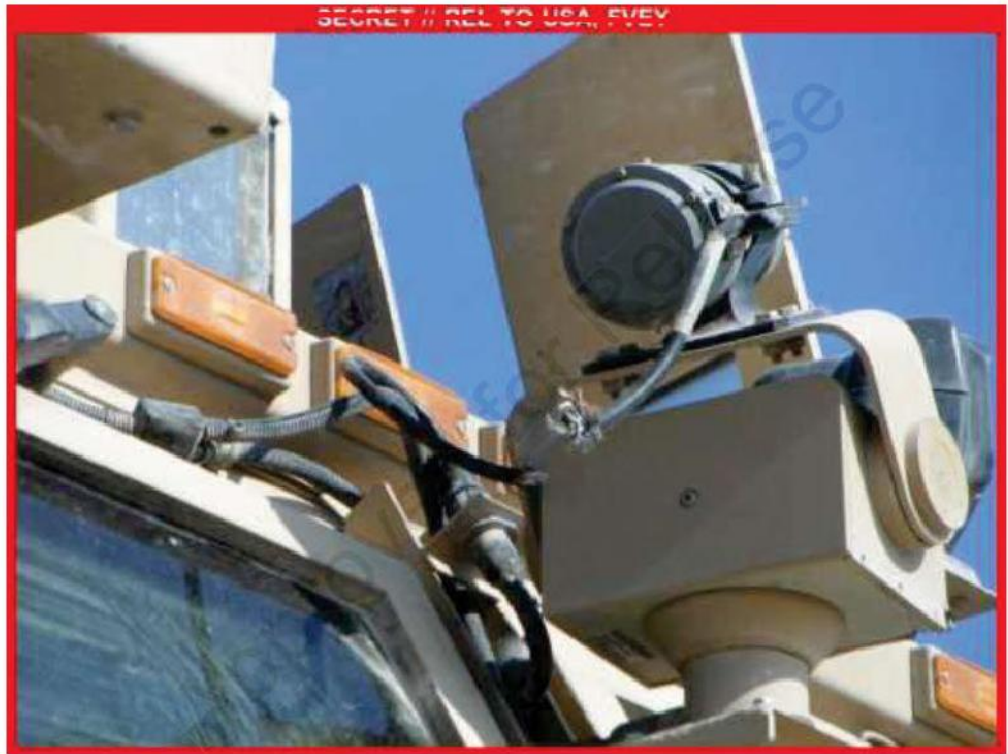
DVE cable severed

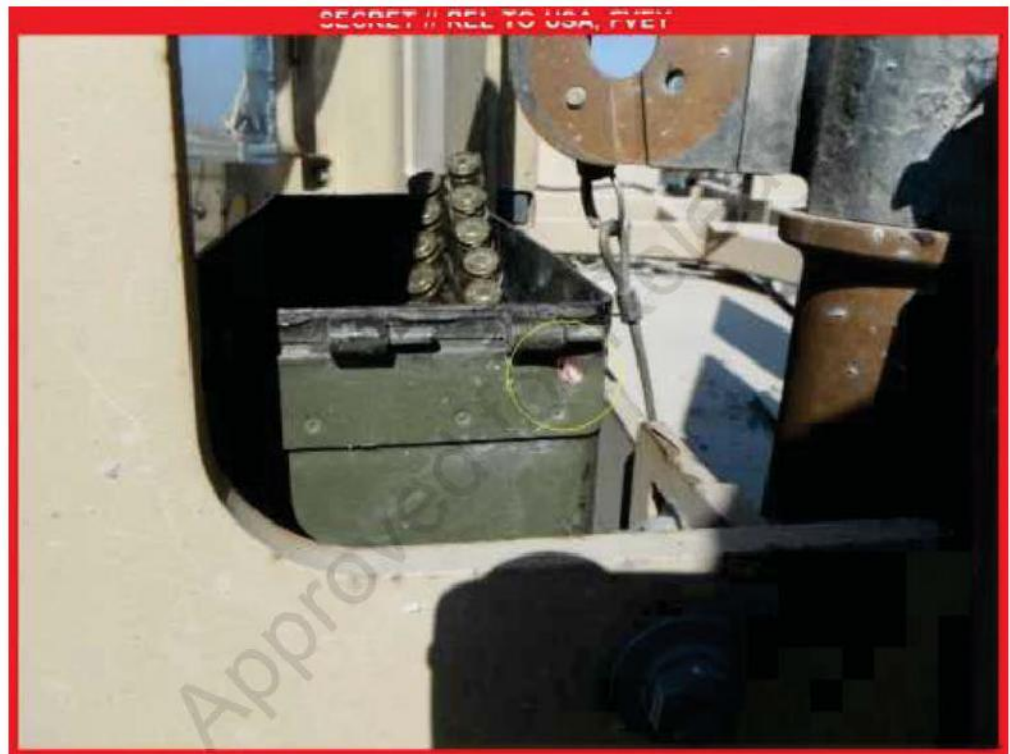
(b)(1)1.4c

on gunners ammo can

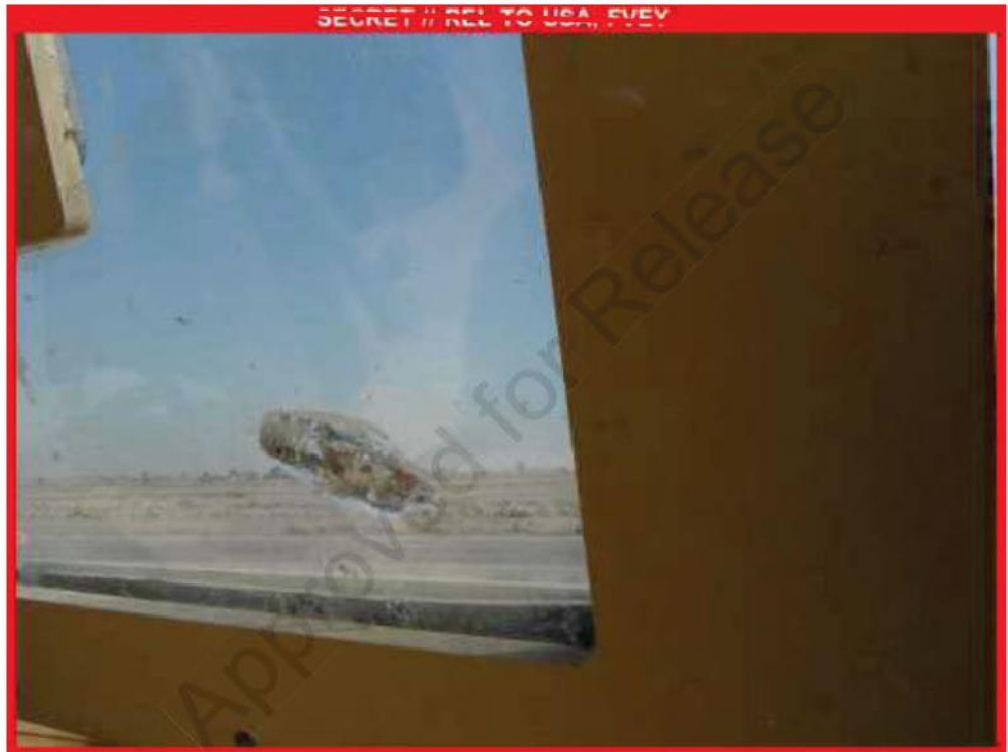
Impact on gunners chicken shield

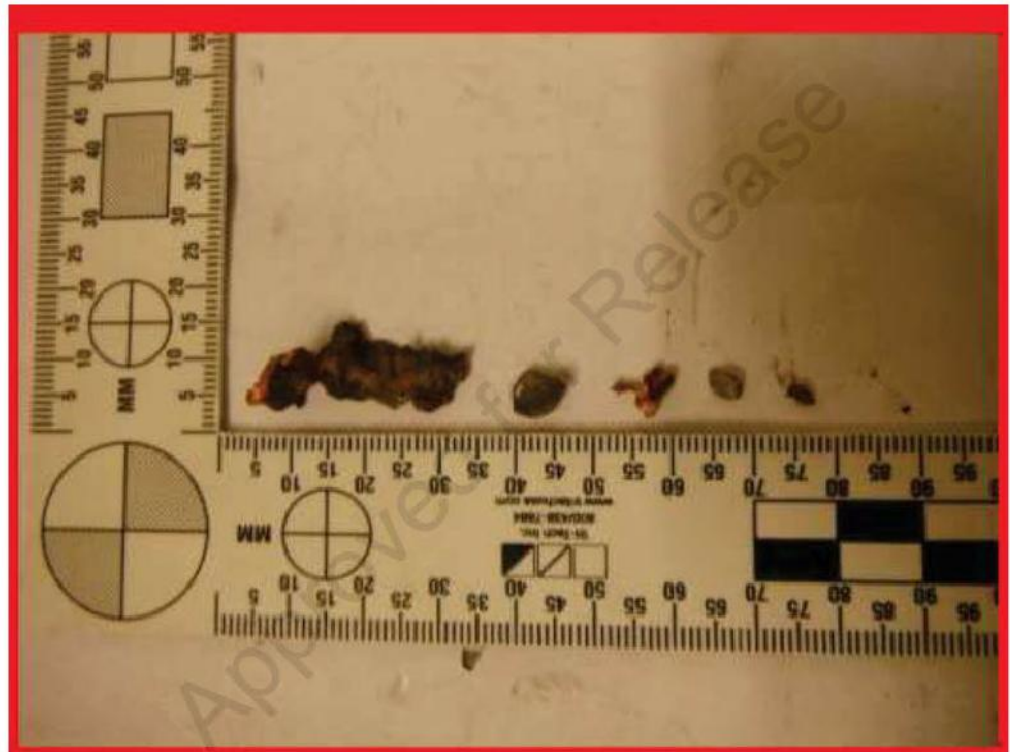
(b)(1)1.4c

recovered from vehicle
